Scope of Work, Drainage Plan, 1:200

Drawing Title		Job No	Dwg No	Rev	Scale	Drawn: MSA	
Phase 3, Drainage Scope of Work		646	/ 3101		1:200 @ A3	10/05/2016	
Revision		Date					
A - New position of soak aways		28/06/2016					
		PCC and Churchwardens					
		Repairs and Improvements St John's Church, Bressingham					
		© Nicholas Warns Architect Ltd.					
  Supported by The National Lottery [®] through the Heritage Lottery Fund		 		64 Bishopgate Norwich, NR1 4AA			T: 01603 622056
				info@nicholaswarns.com			F: 01603 627 393

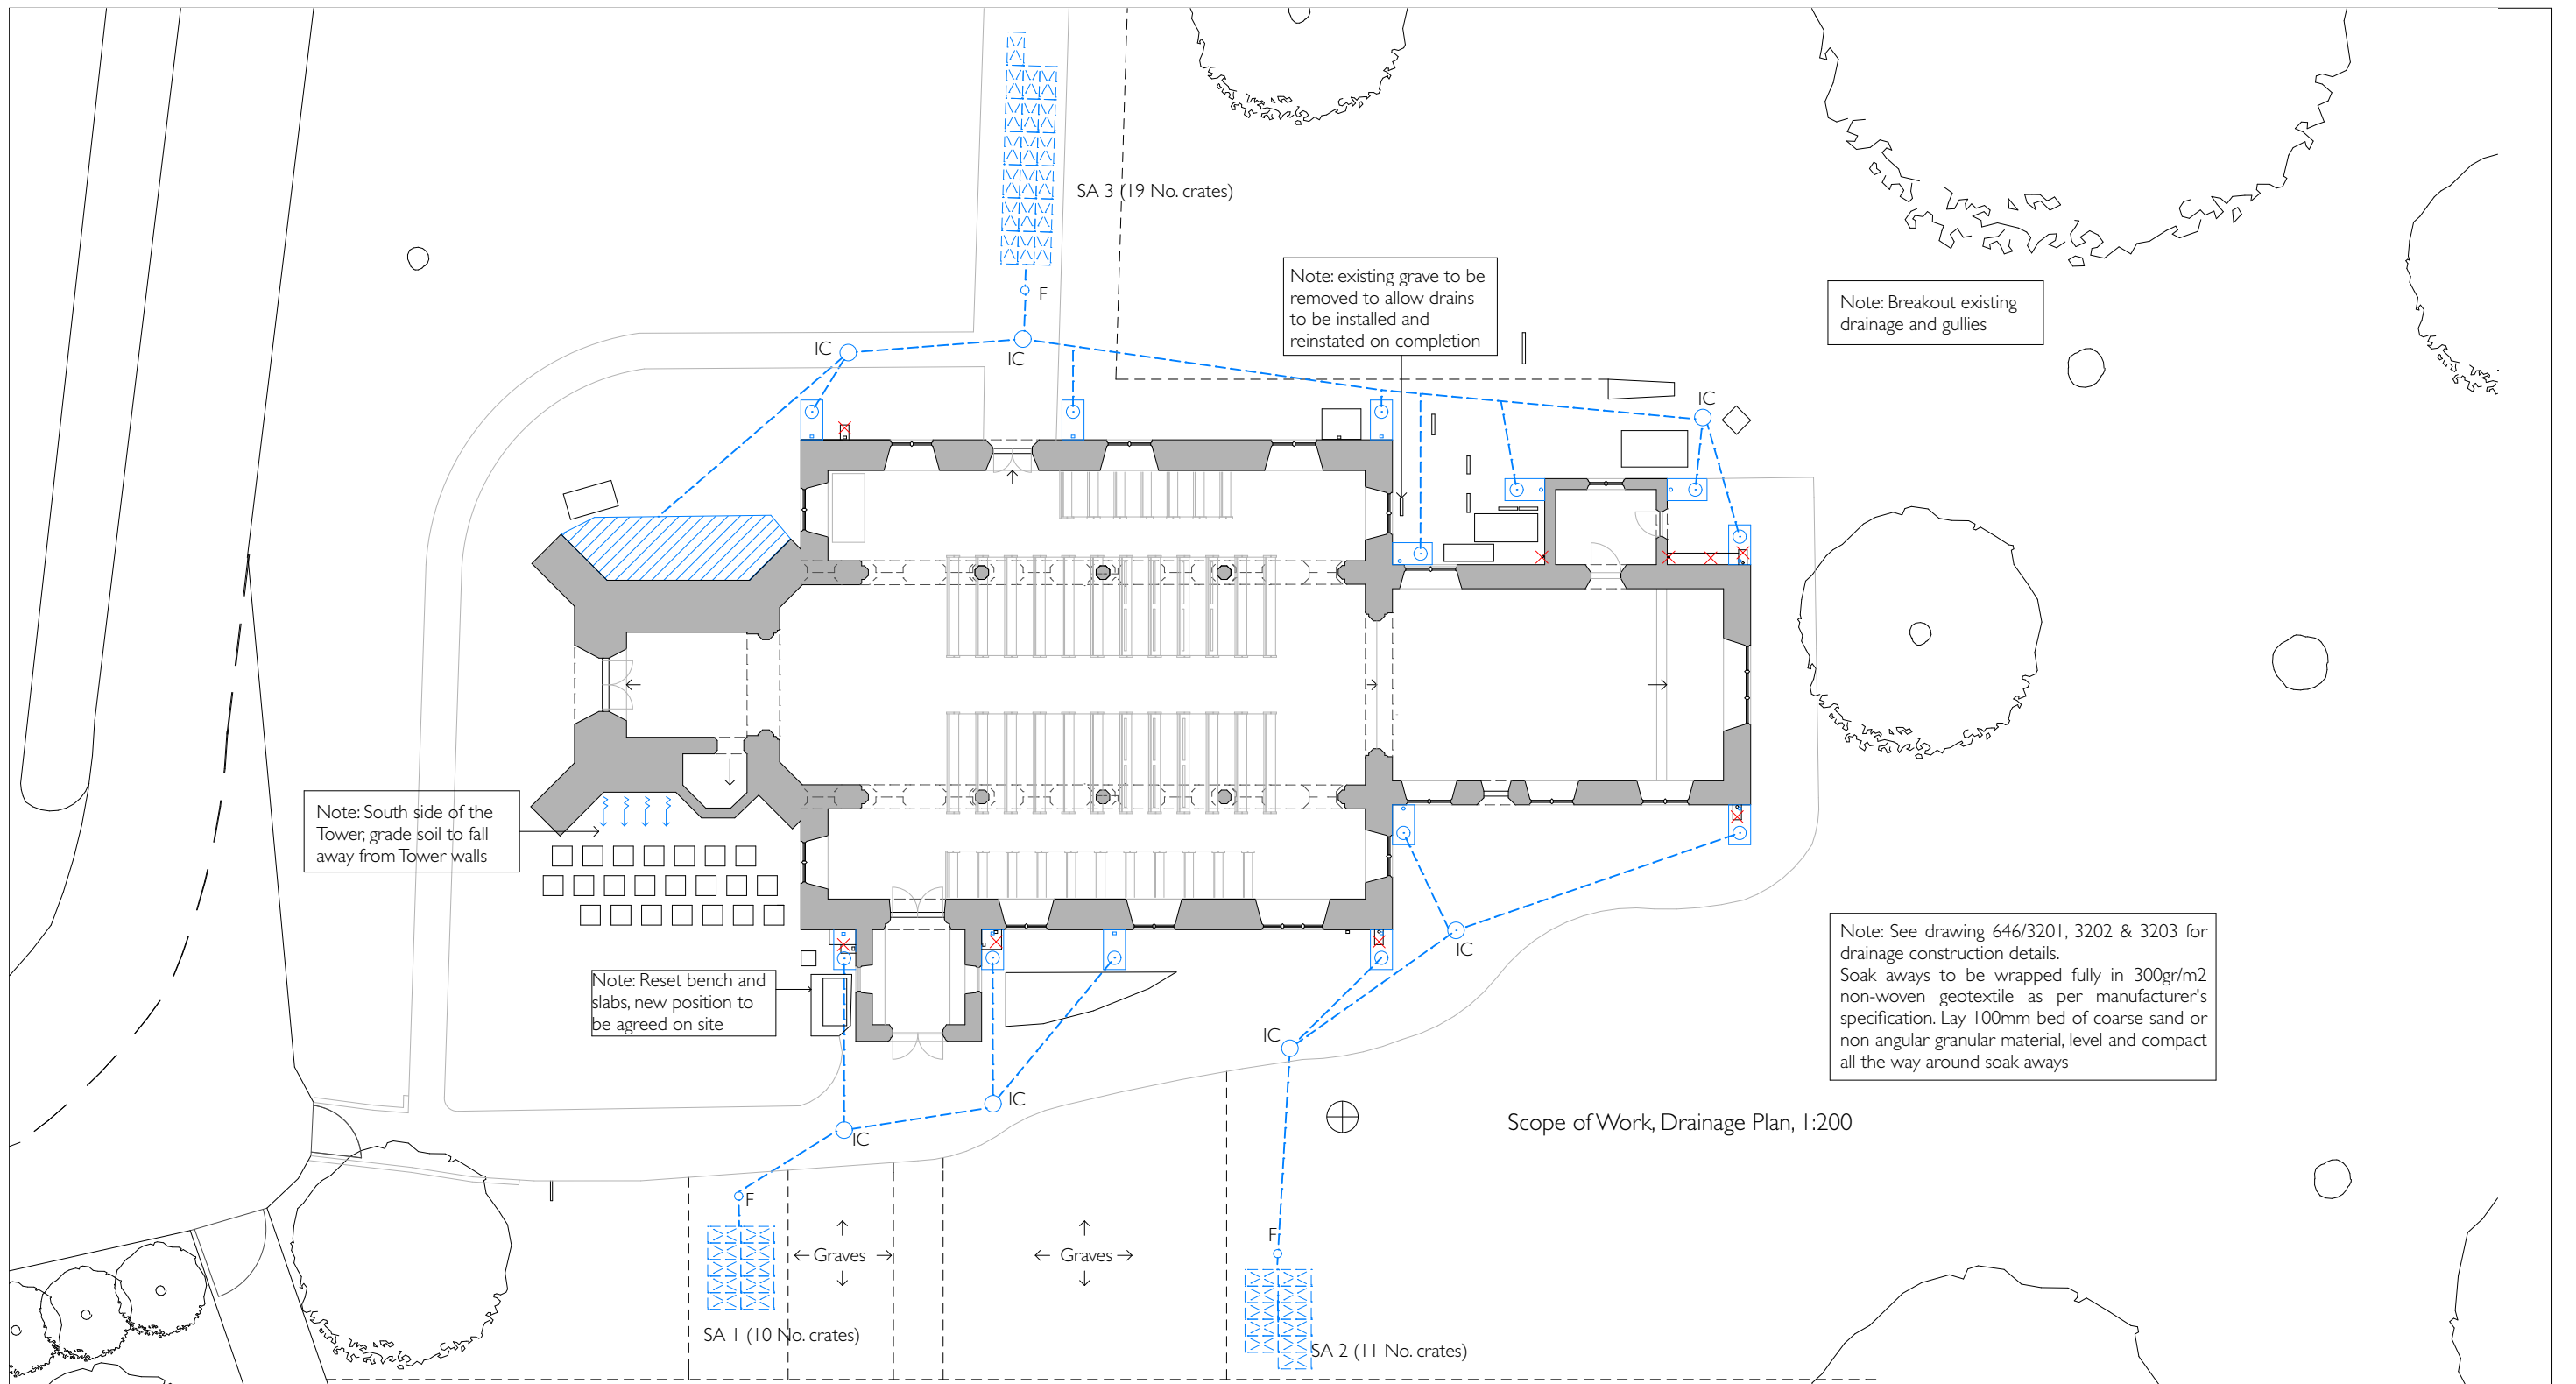
Note: existing grave to be removed to allow drains to be installed and reinstated on completion

Note: Breakout existing drainage and gullies

Note: South side of the Tower, grade soil to fall away from Tower walls

Note: Reset bench and slabs, new position to be agreed on site

Note: See drawing 646/3201, 3202 & 3203 for drainage construction details.
Soak aways to be wrapped fully in 300gr/m2 non-woven geotextile as per manufacturer's specification. Lay 100mm bed of coarse sand or non angular granular material, level and compact all the way around soak aways
